Manhole Inspection Summary

Manhole # S11KK_018MH

Insp Date: **10/25/07 2:32 PM**

Location Address: **2023 N LONGWOOD ST**

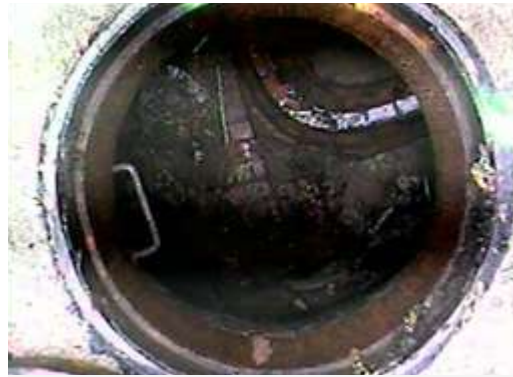
Top View

BENCH DEBRIS

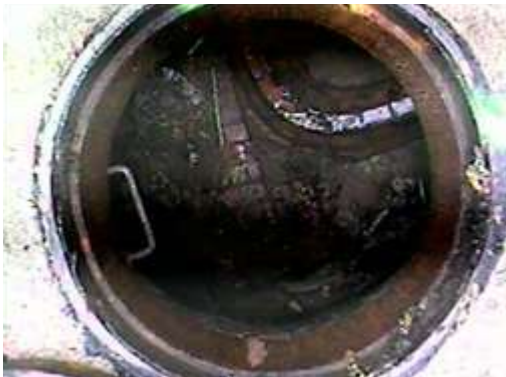
Debris

BENCH DEBRIS

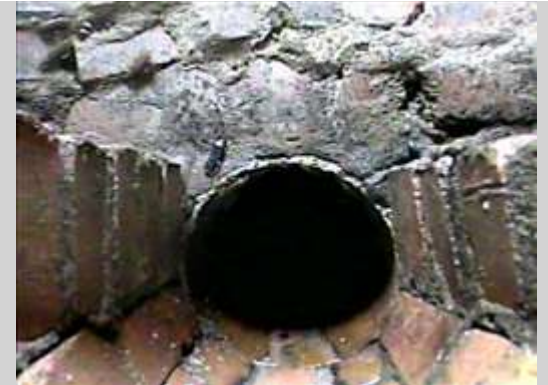
12 O'Clock Outflow

8 in. Circular Gravity Sewer
Pipe Out @ 12 O'Clock

Invert Depth: **4.52** (ft.) Flow Characteristics: **None**

Infiltration: **None** Pipe Seal Cond: **Sound**

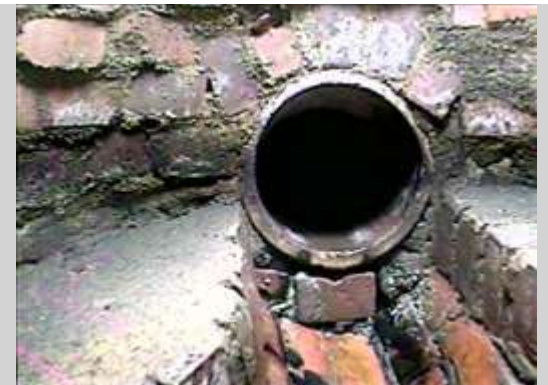
3 O'Clock Inflow

8 in. Circular Gravity Sewer
Pipe In @ 3 O'Clock

Invert Depth: **4.02** (ft.) Flow Characteristics: **Slow**

Infiltration: **None** Pipe Seal Cond: **Sound**
